ŁUKASZ WIEJACZKA, KRZYSZTOF KISZKA, WITOLD BOCHENEK (KRAKÓW–SZYMBARK)

CHANGES OF THE MORPHOLOGY OF THE ROPA RIVER — UPSTREAM AND DOWNSTREAM OF THE KLIMKÓWKA WATER RESERVOIR

Abstract: The paper outlines changes in the channel morphology of the Ropa riverbed over the last six years, taking into account the role of large floods and the Klimkówka water reservoir in shaping the morphology of the riverbed. The analysis was based on annual geodetic measurements of the Ropa riverbed conducted between 2009–2014. The research was carried out in four cross profiles of the riverbed located upstream (1 profile) and downstream (3 profiles) of the reservoir. In order to recognise the direction and scale of morphology changes of the riverbed, additional analyses of water levels in the Ropa River was performed in the analysed multiannual period. The conducted analysis led to the conclusion that floods with extremely large discharges are the key factor causing the deepening of the riverbed downstream from the reservoir. It can be up to about 70 cm deep during a single event. The reservoir is just one additional factor of many which shape the direction and scale of changes to the riverbed. A signif

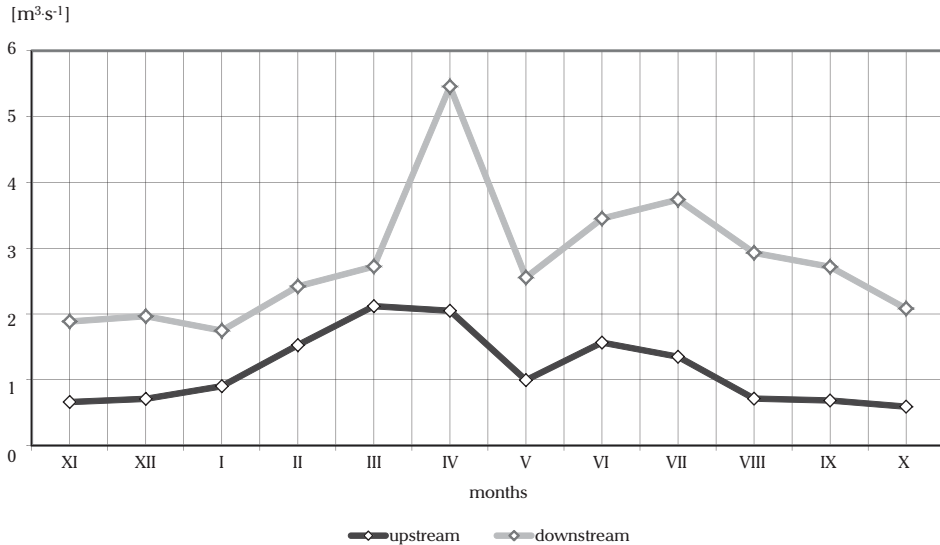
Fig. 2. Mean monthly the Ropa River discharge upstream (excluding the Zdynia River) and downstream of the Klimkówka water reservoir in the years 1995–2006 (after: *Wiejaczka* 2011)

A yearly distribution of discharge in the Ropa River indicates a period of high flows in March and April during the spring snowmelt, as well as in June and July caused by intensive precipitation (average annual sum — 829 mm). Low discharge periods come in the autumn and winter months (Fig. 2). Mean annual discharge on the Ropa River below the Klimkówka water reservoir is $2.81 \text{ m}^3\text{s}^{-1}$ (Wiejaczka 2011).

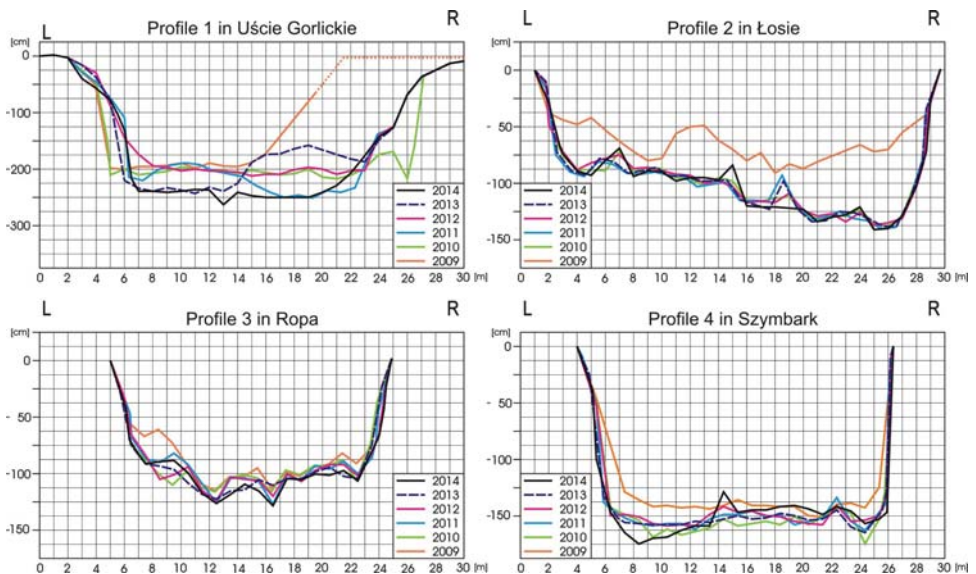
Fig. 4. Cross morphological profiles of the Ropa riverbed in the years 2009–2014

According to Ł. Wiejaczka and W. Bochenek (2013), the bed of the river channel in profile 1 in Uście Gorlickie (Fig. 4) in 2009 was 10 m wide. The depth of the channel (in relation to the mark on the river bank) fluctuated between 170 and 198 cm; 190 cm on average. The bed of the channel with a balanced profile was lined with pebbles up to approx. dozen centimeters in diameter. The right bank was slightly sloped in the lower part and steeply sloped in the upper part. The left bank was lined with riprap and had a vertical profile. In 2010, the levelling of the channel was performed indicatively in the same cross-profile

The trend in the position of the Ropa channel bed at the cross profile 2 in Łosie (Fig. 4) over the years 2009–2014 is presented in table 1. The width of the bed of the Ropa channel amounted to 26 m in 2009 and the depth in relation to the mark ranged between 47 and 100 cm (74 cm on average). The bed of the channel was unlevelled and lined with loose material, mainly with boulders of varying sizes which came from the erosion of the bed and banks of the Ropa River channel. Levelling measurements conducted in 2010 showed a significant deepening of the Ropa channel ranging from about 2–69 cm (35 cm on average). It needs to be noted that the greatest erosion of the bed happened near the right bank; this means that the former slope of the bed towards the right bank was maintained. Such significant erosion has not been observed in the remaining control profiles (Wiejaczka, Bochenek, 2013). Such a significant extent of bed erosion was undoubtedly due to the small distance between the profile and the dam, as well as the high energy of the water without sediment that was discharged from the reservoir during the floods in 2010.

The trends of bed position changes in the Ropa River at the analysed cross profile 3 in the Ropa village are presented in table 1. The Ropa river channel in the profile (Fig. 4) was 17 metres wide both in 2009 and 2010. The bed of the channel in that point is not level with numerous depressions carved into the rock outcrops (shale). In 2009 the depth of the bed of the channel, in relation to the mark, ranged between 56 and 115 cm (90 cm on average). After the floods of 2010, the depth of the channel bed ranged between 73 and 116 cm (Wiejaczka, Bochenek 2013). It should be note that only small gravel bars located at the edge of the channel underwent some changes and the central part of the profile with the rock outcrop remained unchanged. From 2011, levelling measurements showed a tendency for alternate forming and subsequent removal of the bar from the left bank of the channel and regular erosion of the bed (1–10 cm) in the middle and right side of the cross-section. The floods from 2014 caused intensified erosion of the bed which made an incision in the Ropa channel that was

The changes of morphology within the bed of the Ropa channel at profile 4 located in Szymbark reflects the position of the bed in the years 2009–2014 (Tab. 1). In 2009, the bed of the Ropa channel in the profile (Fig. 4), approx. 16 km downstream from the Klimkówka water reservoir, was 18 m wide and its cross profile when compared to the profiles 2 and 3 in Łosie and Ropa was more aligned. The position of the channel bed in relation to the mark on the bank ranged 125–152 cm and 140 cm on average (62–152 cm and 136 cm on average of the channel depth taking into account right bank eroded in 2010). After the floods in May and June 2010, there was a significant decreasing of the riverbed position in the entire cross profile, ranging from about 1–50 cm and 16 cm on average (20 cm on average with right bank position from 2009). The width of the channel slightly increased by 1 m, but the cross profile of the bed shaped by the floods still had a similar course to the one in 2009. The extent of bed erosion was much smaller compared to the profile 2 located in Łosie which was within a short distance of the dam (Wiejaczka, Bochenek 2013).

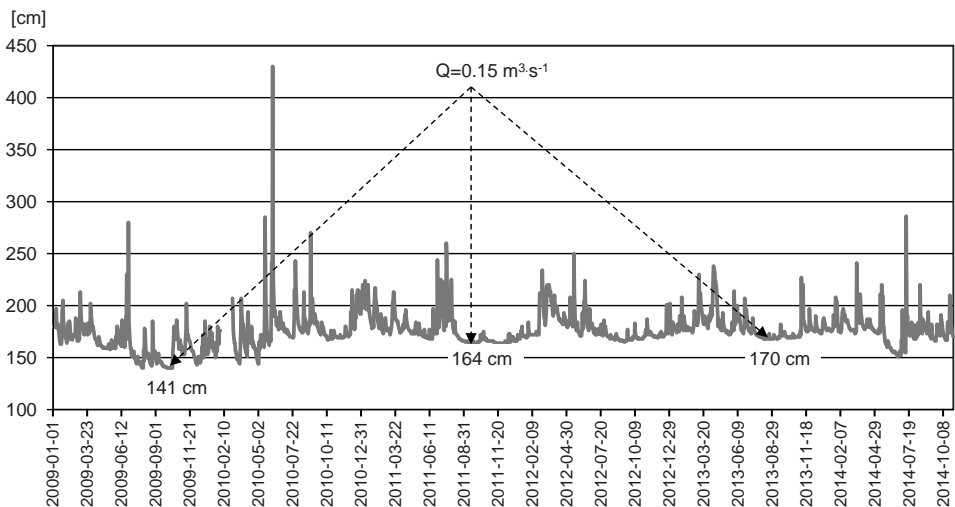
Fig. 5. Daily water levels in the Ropa River between 2009 and 2014 at RWMB water gauge (Kraków) in Uście Gorlickie (with marked water levels for discharge equal to $0.15 \text{ m}^3 \text{ s}^{-1}$)

The analysis of daily water levels in the Ropa River at Uście Gorlickie (Fig. 5) shows that at the flow of $0.15 \text{ m}^3\text{s}^{-1}$ in 2009, the water level oscillated around 141 cm; while in 2011, with the same flow rate, the water level amounted to 164 cm. The raising of the bed by 23 cm was the result of a large flood from June 2010 when intensive accumulation of river material in that section of the river was observed. It could be caused by two factors, i.e. the backwater pinching out further upstream as well as the fact that the Ropa River could be blocked by the Zdynia River (Fig. 1) which has a higher flow than the Ropa River. In 2013 a further build-up of the bed of the channel was observed which is indicated by the fact that the water level is several centimetres higher even though the flow remained the same. The impact of the 2010 flood on the raising of the Ropa river bed is also noticeable in the measurements of the minimum water levels in the river (Fig. 6).
